PRODUCT AFFECTED:

JUNO-60/6

SUBJECT

A Failure of IC 3R01

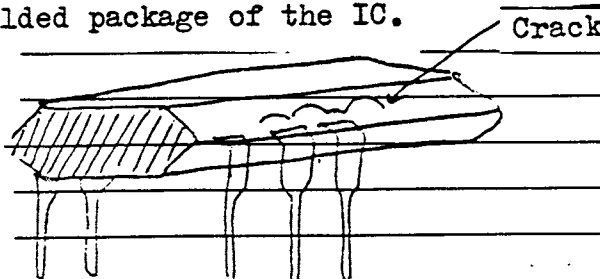
From our repair record in Japan market, it was found that some IC 3R01 in JUNO-60/6 became in failure and it was caused by a crack which happened on the molded package of the IC.

NOTE : JUNO-60/6 show a phenomenon as shown below on each function if one of IC 3R01 are in failure:

VCA ENV. : Output volume does not change, or sometimes it change, or output sound leaks, or no output sound.

VCF ENV. : Sound does not change by ENV MOD., or sometimes it change.

DCO PWM. : Sound does not change by MOD ENV., or sometimes it change.

It seems that there is a possibility for IC 3R01 to be mixed in JUNO-60/6 with above serial numbers. We wish you to pay your attention to IC 3R01 when you have a chance to repair them. We advise you to replace the IC with a crack with new one which is sent under separate air service, even though the IC works normally, if you would find it.
