### Intermittent Speedo Repair

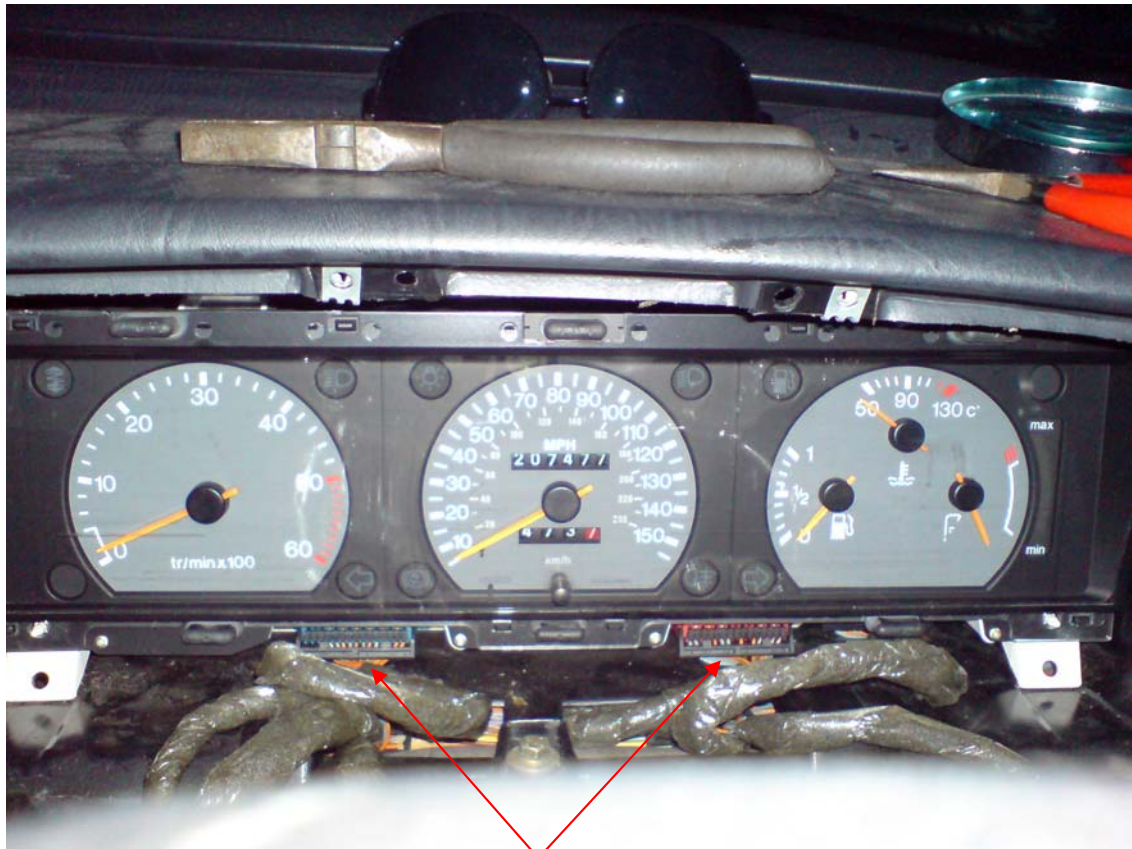
Photo 1

The fault lies in the red coloured multiplug which connects part of the instrument cluster to the outside world. The individual cables terminate in a red multiplug which in turn mates with a socket on the instrument cluster PCB. However, the individual cables are quite stiff and are expected to turn through 90deg just after leaving the multiplug. The instrument cluster is a neat fit inside the dash and the connectors are mounted along the bottom edge of the PCB. When the instrument cluster is mounted in its normal position inside the dash the bottom edge of the PCB is only just above the dash chassis. The cables leaving the multiplug face downwards and must turn sharply through 90degrees to miss the dash chassis. The individual cores are therefore in a permanently stressed state relying on the little knife edges inside the multiplug to keep them connected.

Cables stressed here as they leave the multiplug(s)

I don't know for sure why the core associated with the speedo should be any more stressed compared to any other core but it seems prone to failure. It may be that all cores are stressed by the same amount but because the core to the speedo is carrying only a 1v pulse (compared to other cores carrying nearer 12v) then it is much more vulnerable to degradation in contact quality.

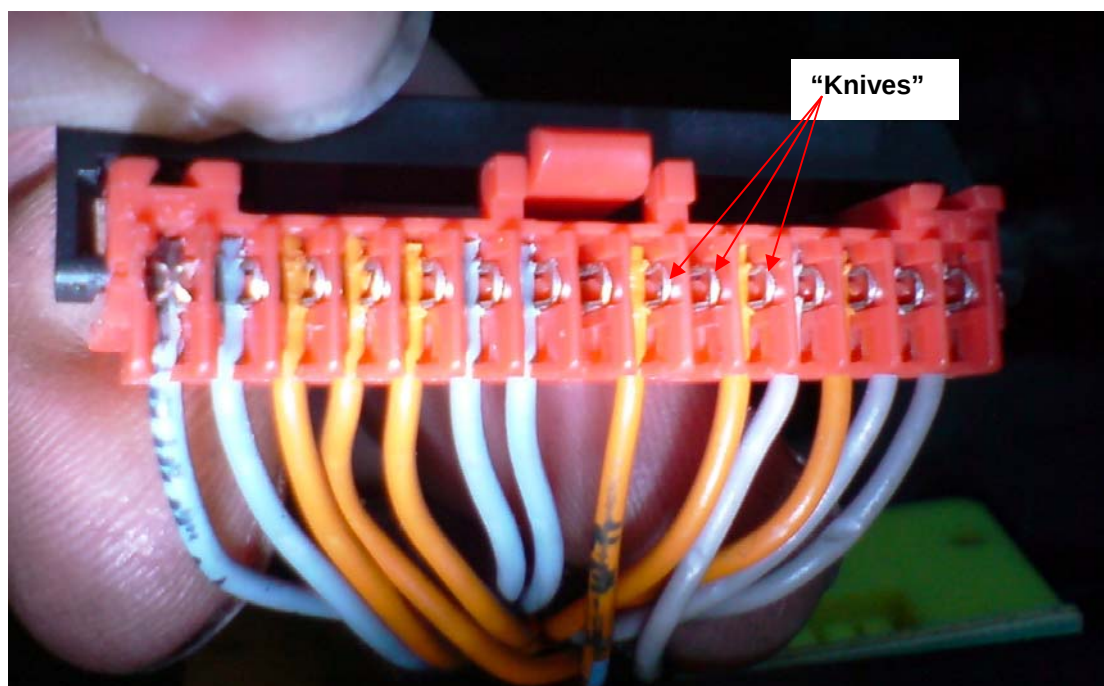
The cables are pressed into each cable groove by a crimping tool. As each cable enters its respective groove the sharp edges of the "knives" slice through the insulation and the copper

core of the cable is trapped at the bottom of the two tapering knife edges. This is where the electrical connection is made. The cable relies on the friction between the insulation and knives to keep the cable in its groove. The black plastic comb also helps to keep them in place. However, the stress on the cables due to inadequate turning space causes the insulation to slip on the knives allowing the cable to rise out of the tapering knife edges. As it does so it loses electrical contact.

My solution was simply to bend over the tops of the pair associated with the cable with the problem. In the case of the faulty speedo the cable carrying the pulse signal from the speed sender on the final drive is connected to Pin 1. I took a pair of very small pointed nose pliers and bent over the two loops at the tops of the knives towards each other. This has the effect of pushing the cable further into the tapering knives and prevents them from coming back out.
