# GLASS AUDIO

## Renovating the Scott 222C, Part 1

This author's renovation of an H.H. Scott 222C integrated amplifier is truly a labor of love and incorporates up-to-date components.

By Charles Hansen

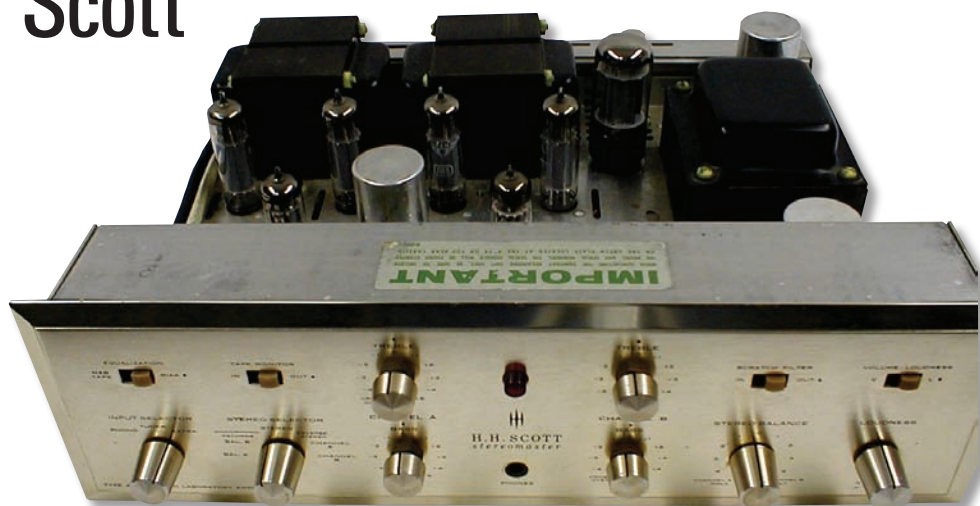
PHOTO 1: Front view of 222C.

My own choice was based on cosmetic condition, because new electronic components are readily available, while high-quality front panels are not (Photo 1). Some of the descriptions in this article refer to the 222C and 222D schematics. You should download them from the H.H. Scott website<sup>2</sup>, because they are not reproduced here.

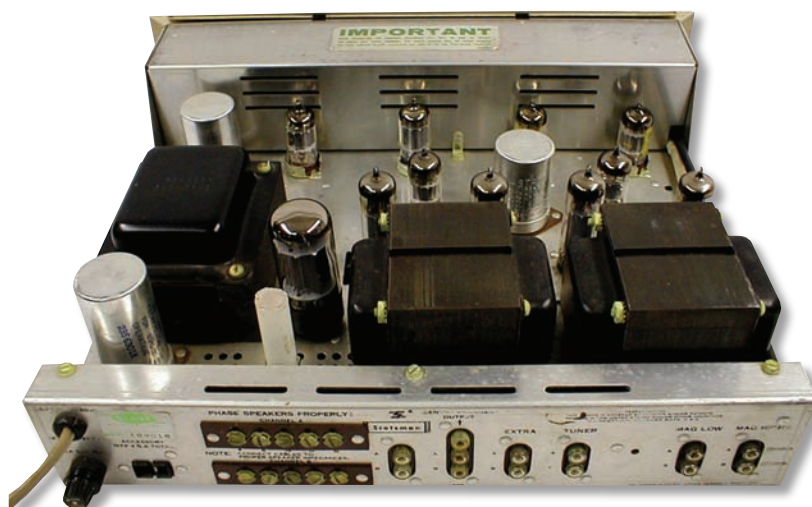
PHOTO 2: Rear view of 222C.

If you intend to do any further testing, label the various control functions on the aluminum front sub-chassis near the controls and switches. Remove the front panel and wrap it in bubble wrap for protection until you finish all the work. The rear and interior views of the 222C that I purchased are shown in Photos 2 and 3.
