# Citroen XM Strut Top Repair Manual

| Version 1.0 | <i>Released as Draft. Further revisions will be issued in due course. Appendices A &amp; B to be completed. Appendix C to be added. Check the Self-Help section here for updates: <a href="http://club-xm.com/forum">club-xm.com/forum</a></i> |

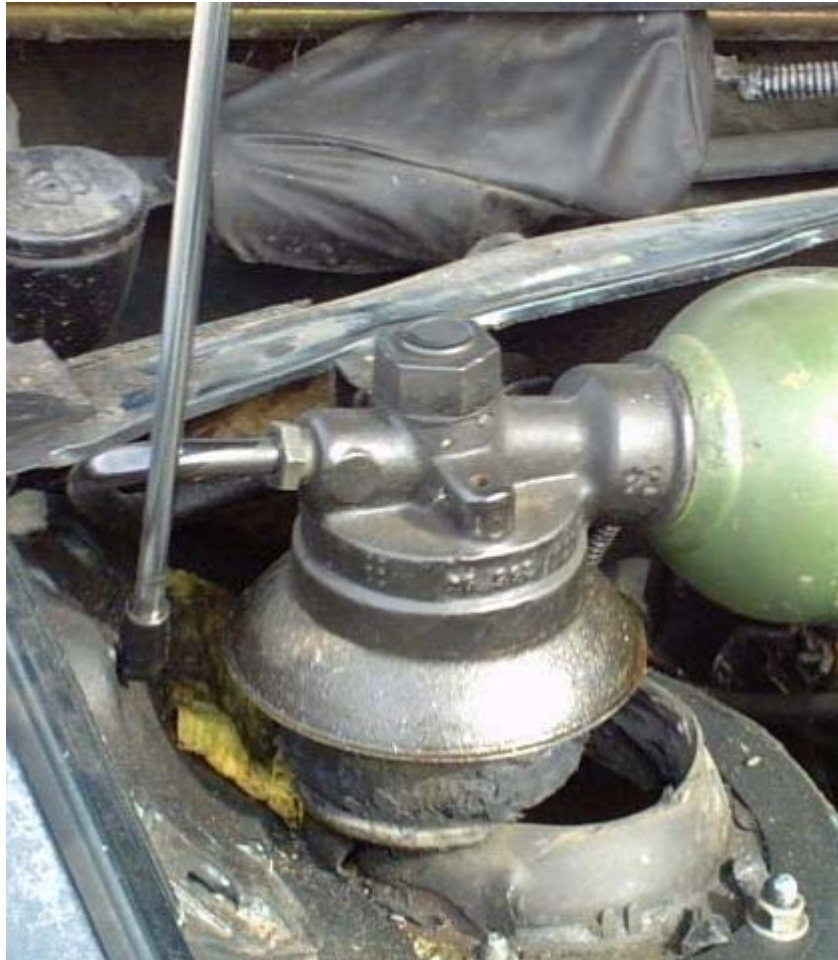
*This is not a sight you want to see.*

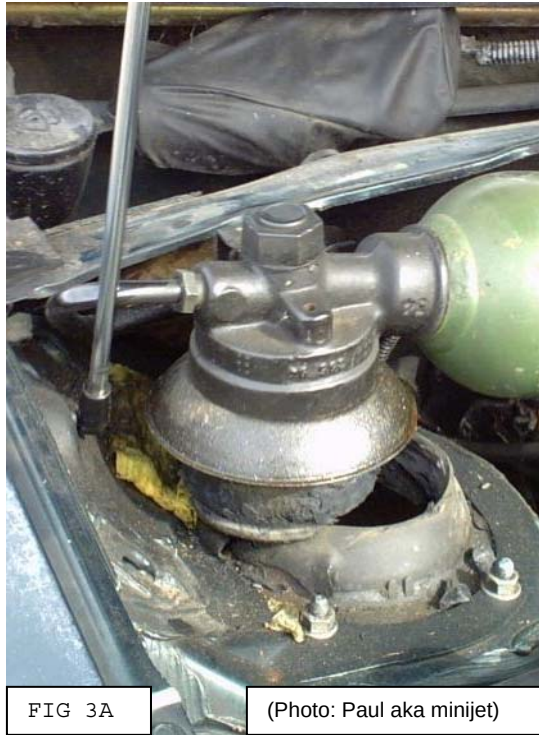
The first common failure is the deterioration of the rubber itself. After some time the Rubber Moulding (Part 3) appears to be 'torn' out of its fixings. This may occur if the strut top is subjected to greater forces than those for which it was designed. This can occur if the car is run with flat spheres and therefore the shock coming up through the strut from the roadwheel is transmitted directly through the rubber due to the lack of a 'spring' in the sphere. To make matters worse, the lower section of Steel Cylinder (Part 1) is a smaller diameter than the central hole at the top of the cone in the Anchor Plate (Part 2). When the moulded Rubber (Part 3) finally fails, the strut pushes Parts 1, 3, 4 and 5 upwards and through the inner wheel arch leaving the Anchor Plate Part 2 behind.

There is not enough space inside the engine compartment to accommodate this extra height and therefore the strut top pushes on the inside of the bonnet lid bending it up locally in the process. This bend in the bonnet is usually severe and can sometimes break the bonnet hinges at the side closest to the failed strut top.

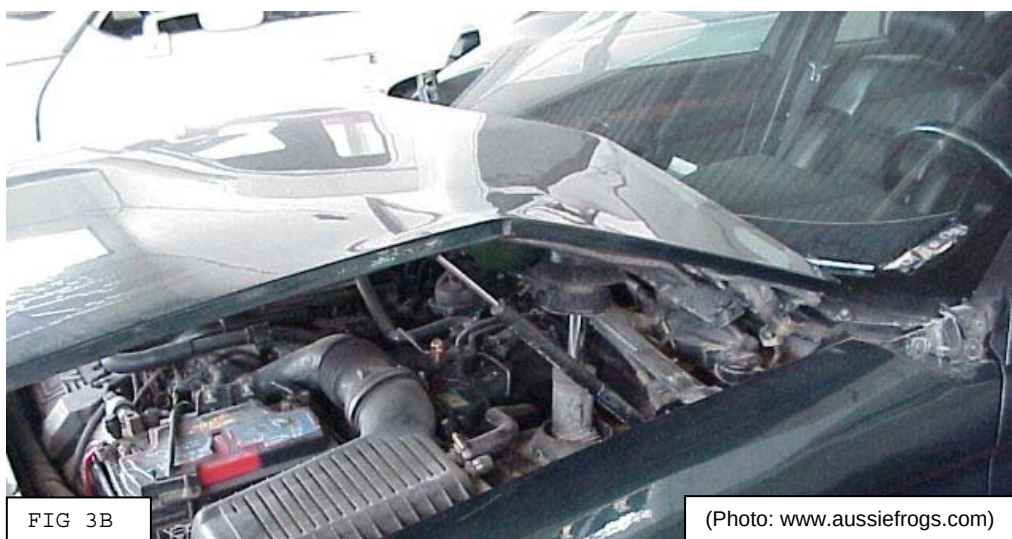
Here you can see the strut having pushed the strut top clear of the body and the lower part of the strut sticking through the hole that is left.

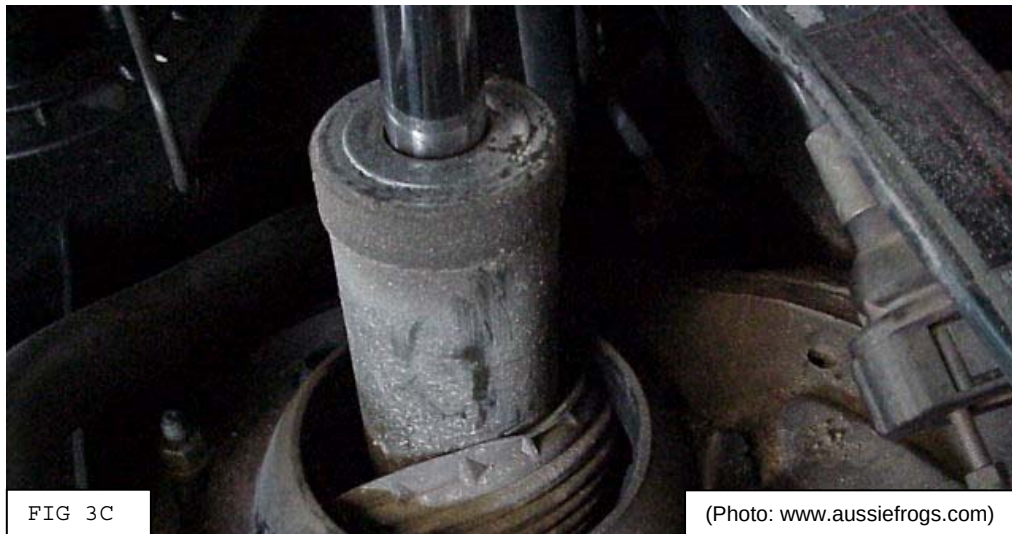
When the Anchor Plate Part 2 is removed from the car after failure this is what it looks like:

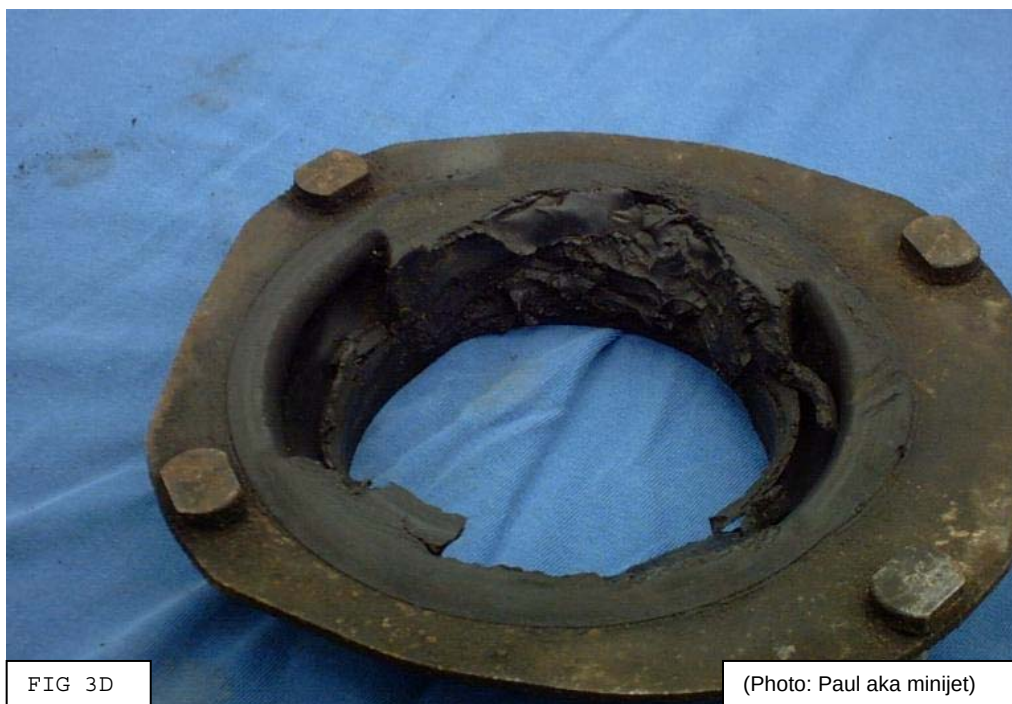
As you can see the rubber appears to be 'torn' out of the anchor plate.

Once removed from the car the associated strut top looks something like this:

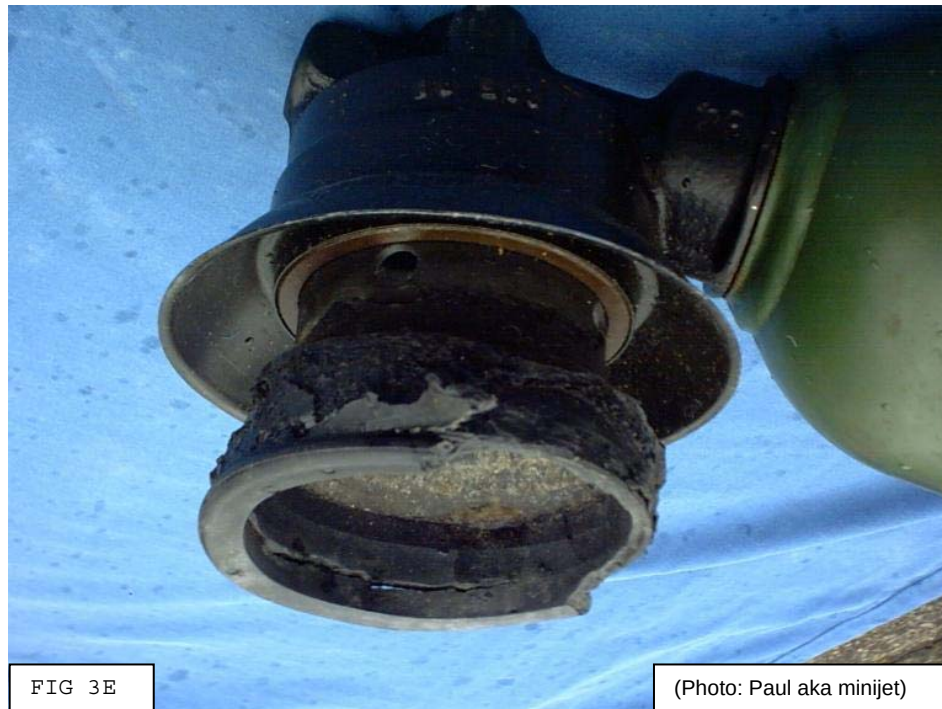
Part of the lower rim at the right hand side is missing. It is likely that this was sheared off resulting in the reduction of the diameter to allow it to pass up through the cone section of the Anchor Plate (Part 2).

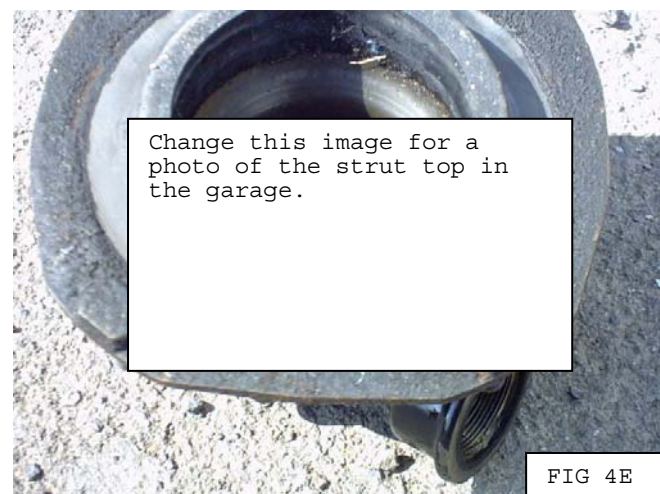
This is another strut top which would be suitable for this type of repair. Although the rubber moulding Part 3 has become completely detached from the Anchor Plate Part 2 it is still in good condition and still fully adhered to the Steel Cylinder Part 1.

Ultimately it is a judgement you must make whether the rubber moulding is suitable for reuse. There are too many permutations of partial degradation to analyse them here. If you are in any doubt as to the suitability for reuse then consider Repair Type 2.
