### Intermittent Speedo Repair

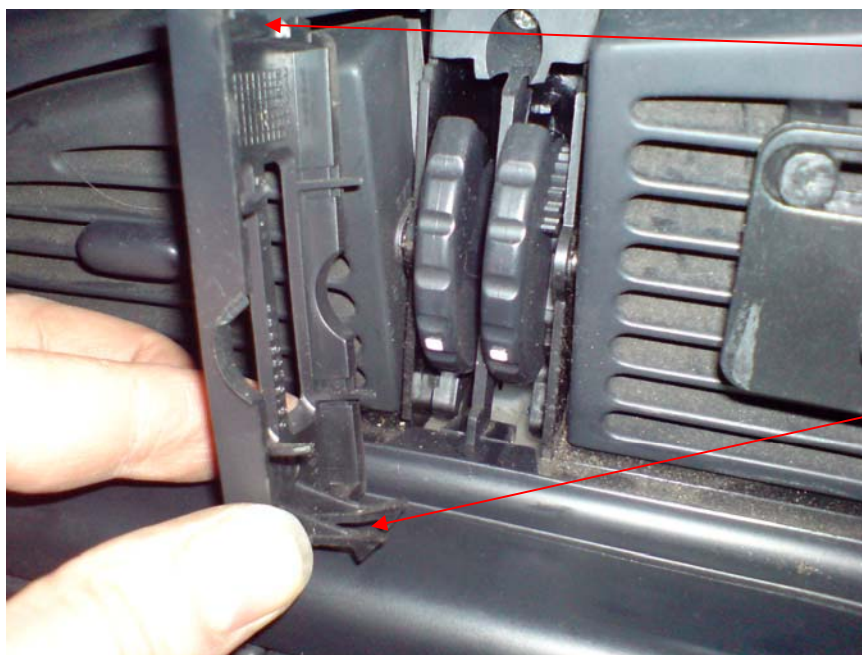
Photo 3

Top clip

Bottom clips

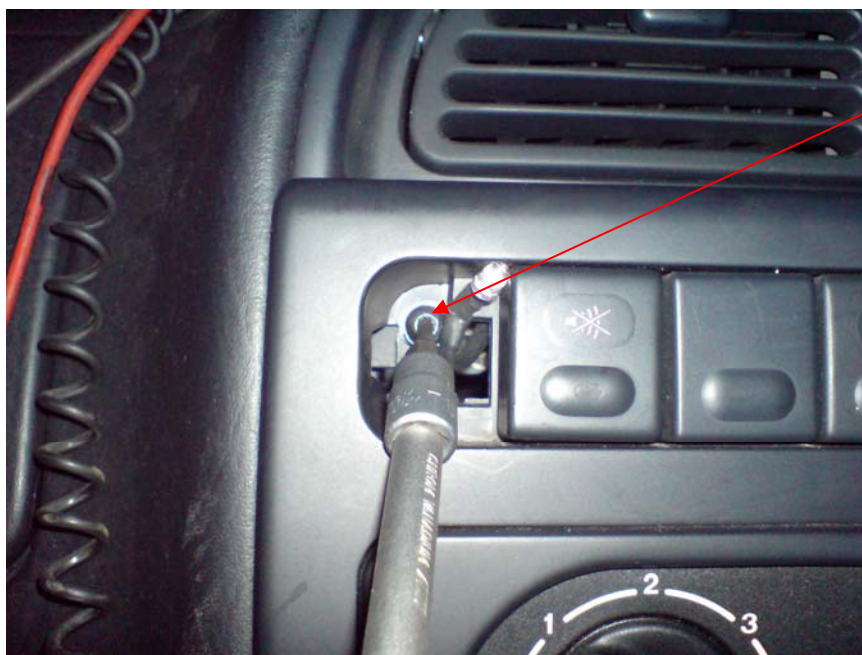
Photo 9

Torx fixing screws

Remove the Torx screw behind the alarm LED bezel

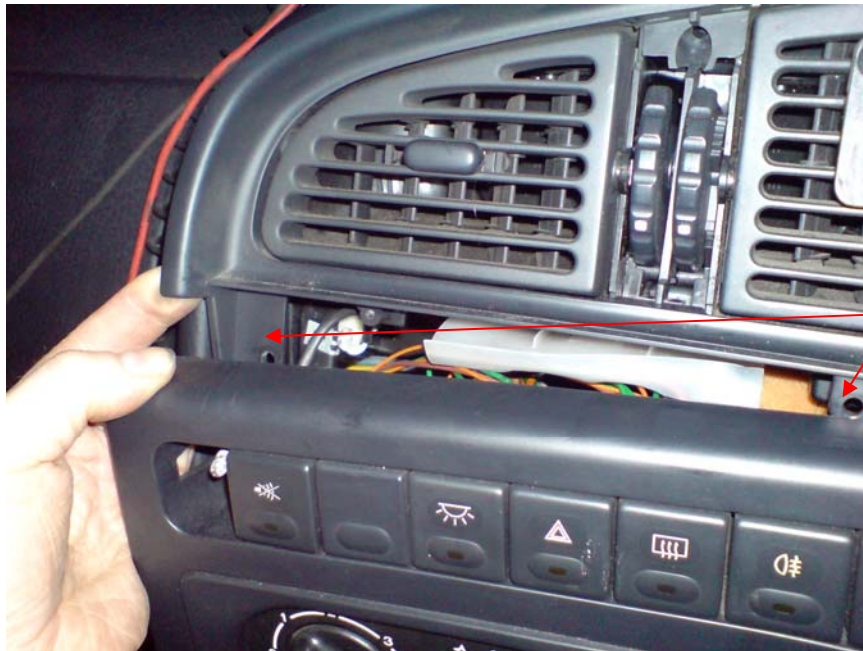
**Photo 10**

The two tangs protrude below the upper level of the lower dash and make it difficult to withdraw the shroud

The lower half of the dash should now be free and it should pull forward at the top edge by about 10mm or so. There should now be enough clearance to be able to remove the shroud that encompasses the instrument cluster. You will find that the left hand side of this shroud gets stuck because there are two tangs which stick downwards behind the lower part of the dash. To get the shroud past the lower dash the lower dash must be prised down and towards the rear of the car by approx 30mm.

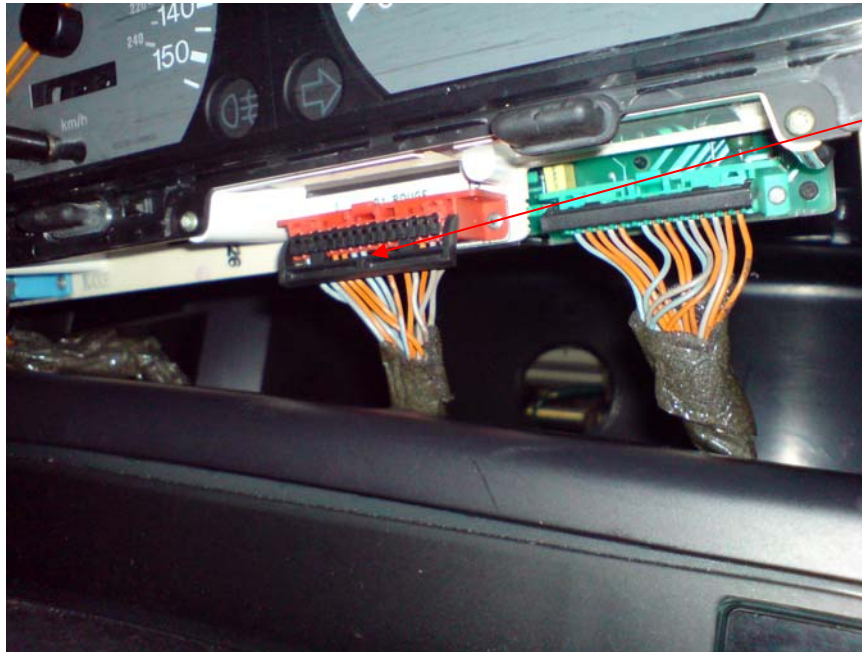
Photo 18

This is the normal  
"Locked" position of  
the plug handle.

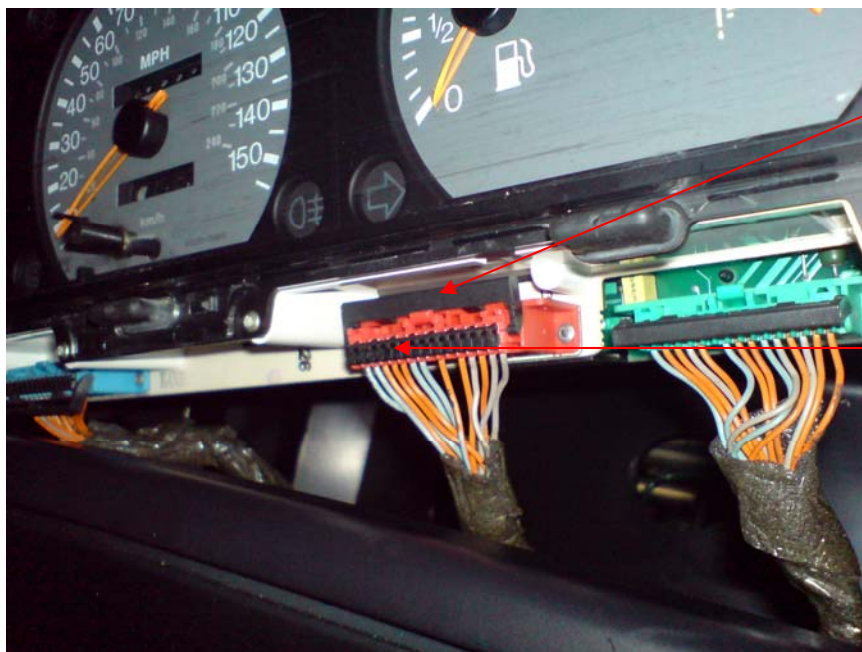
Photo 19

Black plastic "comb"  
which covers the  
cable terminations.  
This needs to be  
removed as  
described below

Rotate the plug  
handle upwards and  
you will feel a click  
when the plug  
releases from the  
socket.

Pry the black plastic comb as shown in Photo19 out of the plug with a small screwdriver. What you see at the back of the plug looks like this (sorry for the quality of the photograph, macro photography is very difficult with these digital cameras. There's no manual control over focus)

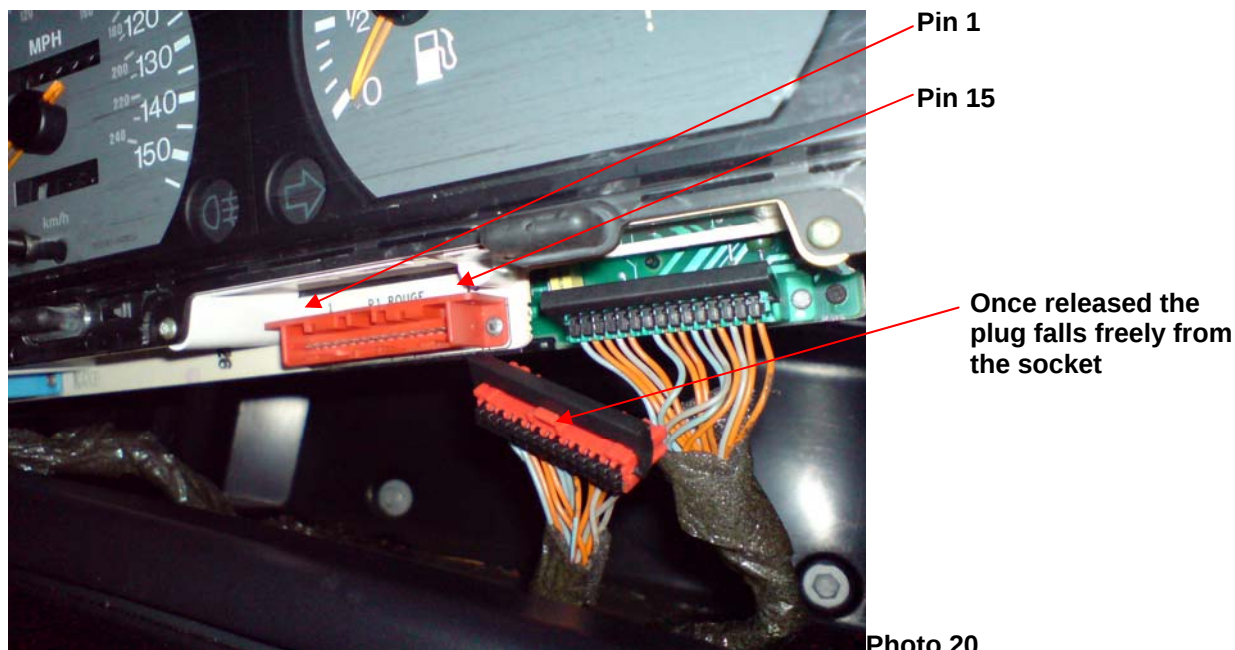
core of the cable is trapped at the bottom of the two tapering knife edges. This is where the electrical connection is made. The cable relies on the friction between the insulation and knives to keep the cable in its groove. The black plastic comb also helps to keep them in place. However, the stress on the cables due to inadequate turning space causes the insulation to slip on the knives allowing the cable to rise out of the tapering knife edges. As it does so it loses electrical contact.

Disconnect all three plugs and remove the instrument cluster from the dash. This would be a good time to test all the lamps on the instrument cluster and replace any broken/missing ones. Please note some may be deliberately missing if the feature is not installed on your particular model. At this point it is also possible to access the rear of the Warning Lamp panel which houses the lamps for the ignition, handbrake, stop lamp etc etc. Check all lamps and replace as necessary.
