# POOGE for eBay Test Gear

How to test bargain equipment you might find on

eBay or from surplus equipment dealers.

By Charles Hansen

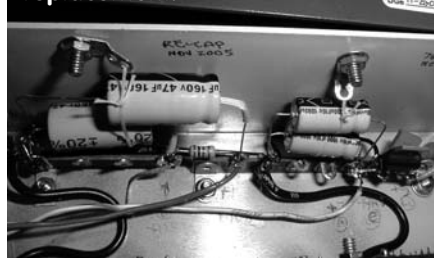
**PHOTO 1: IG-4505 capacitor replacement.**

Before tackling the logic problem, I installed four new 105° C electrolytic caps. I always mark the chassis near the replaced parts (**Photo 1**) so the next owner will know about the modifications.

Make sure you use 105° C replacement electrolytics rather than the cheaper 71° C or 85° C parts. They cost about 30% more, but the higher operating temperature buys you twice the reliability and a 25% surge voltage margin. These 105° C electrolytics are readily available from Mouser ([www.mouser.com](http://www.mouser.com)).

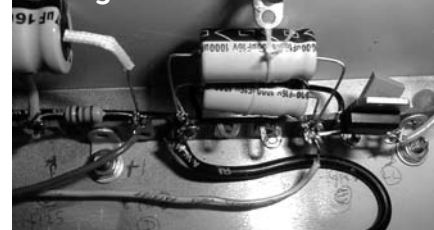
**PHOTO 2: IG-4505 power supply redesign.**

lowed me to remove the power transistor and two extraneous zeners and resistors (R102, R103, ZD101, and ZD102; **Fig. 1** and **Photo 2**). This brought the logic supply up to 4.95V and allowed all the time-base functions to operate properly with a

I decided to redesign the power supply to use a 78T05 5V regulator IC. This al-

worst-case timing error of 0.2%. However, the raw 7.1V supply at the input to the new 78T05 regulator IC was less than the minimum 7.5V required for good regulation.
